Cummins ECM Reference Notes

This document should be used as a reference for Cummins ECM specific operational functions that all tuners should be aware of.

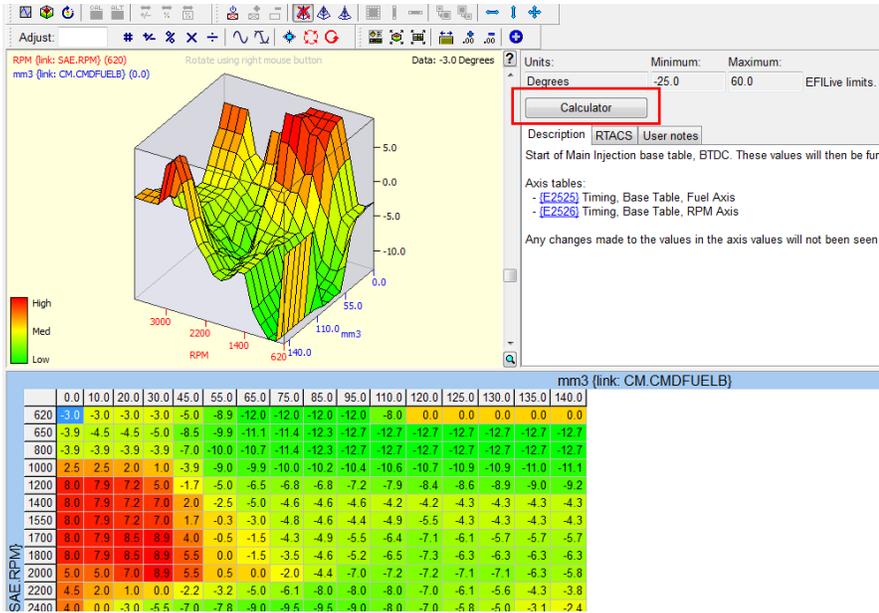
When looking at table {E2503}, if you click on the [Calculator] button a new window opens with a table containing the current timing percentages that were calculated based on the values in the tables: E2503 (Main Timing), D0782 (Fuel pressure) and D0502 (Main injection pulse width).

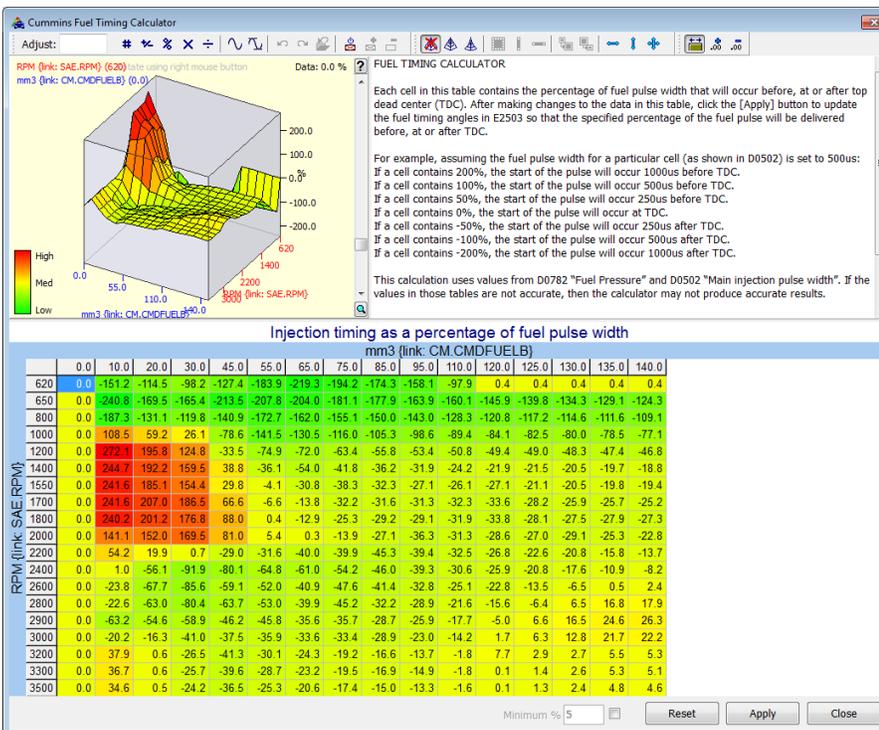
Timing calculator window:

The values in the timing calculator table are calculated as follows:

For each cell in E2503, the tuning software looks up (with interpolation) the matching MPa value from the table: D0782. Uses that MPa value to lookup (with interpolation) the injection pulse width in microseconds (i.e. "us") in table D0502. Sets the timing calculator table cell values to:

A negative value just means the injection pulse starts and finishes after top dead center. It should be noted that the ECM does have some limitations when it will start and end an injection event, the above is purely for example.

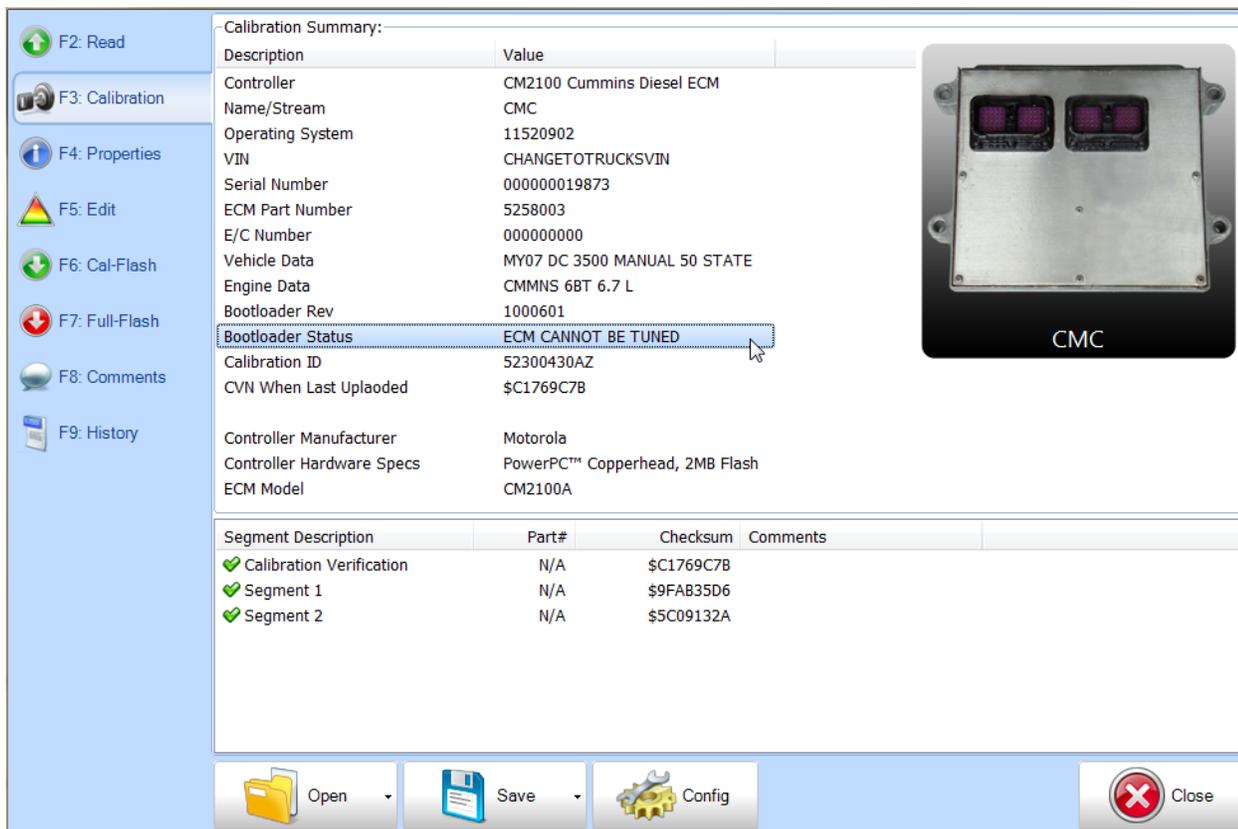
The screenshot displays the EFILive V8 software interface. On the left is a navigation pane with icons for F2: Read, F3: Calibration, F4: Properties, F5: Edit, F6: Cal-Flash, F7: Full-Flash, F8: Comments, and F9: History. The main window shows a 'Calibration Summary' table with the following data:

Description	Value
Controller	CM2100 Cummins Diesel ECM
Name/Stream	CMC
Operating System	11520902
VIN	CHANGETOTRUCKSVIN
Serial Number	000000019873
ECM Part Number	5258003
E/C Number	000000000
Vehicle Data	MY07 DC 3500 MANUAL 50 STATE
Engine Data	CMMNS 6BT 6.7 L
Bootloader Rev	1000601
Bootloader Status	ECM CANNOT BE TUNED
Calibration ID	52300430AZ
CVN When Last Uploaded	\$C1769C7B
Controller Manufacturer	Motorola
Controller Hardware Specs	PowerPC™ Copperhead, 2MB Flash
ECM Model	CM2100A

If the number is 1000601 the ECM has the Anti-Tuning update and therefore cannot be reflashed with a modified tune. If the number is 1000500, 1000502 or 1000503 then it will accept a modified tune. Just below the Bootloader Rev field is also a status field indicating if the ECM can be tuned.
